14.0 SOILS, GEOLOGY AND CONTAMINATION

14.1 INTRODUCTION

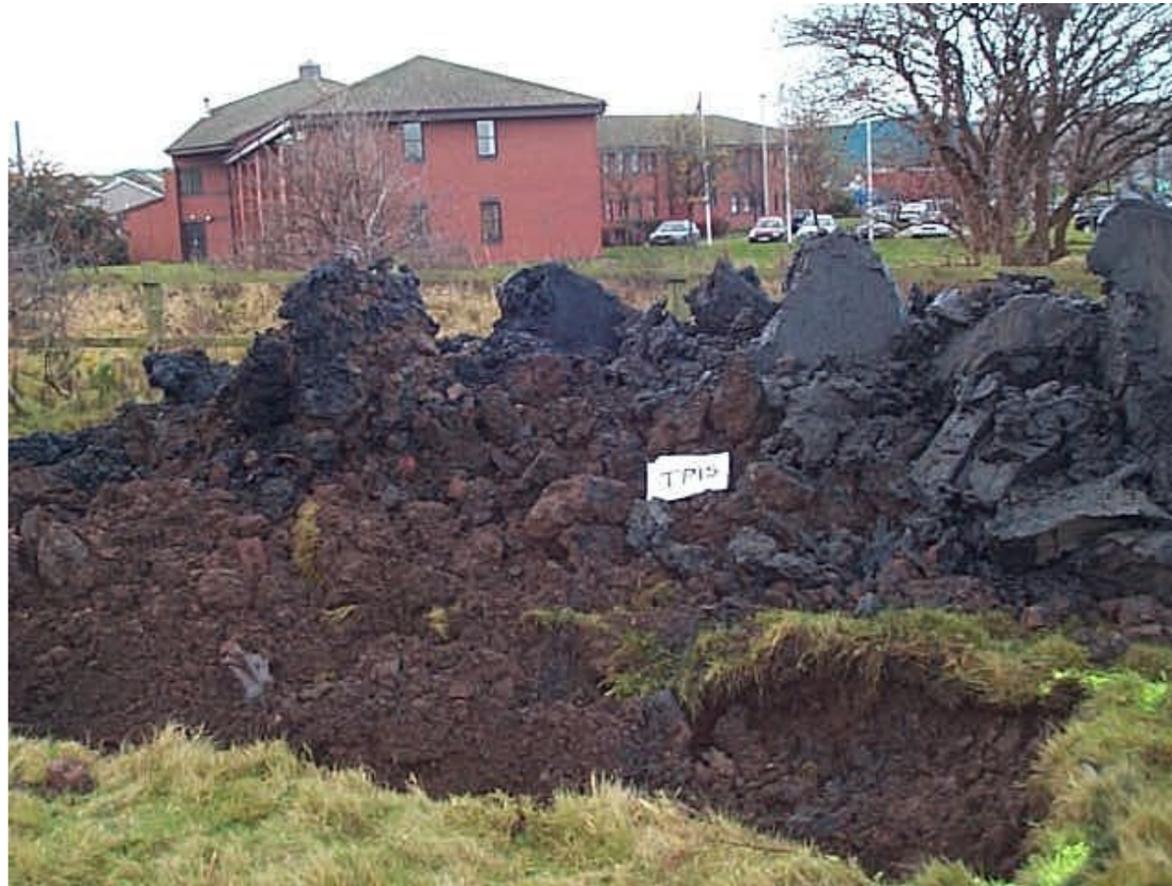
Plate 14.1(a) - Dark grey/black, silty clayey, galligu chemical waste encountered in TP 15

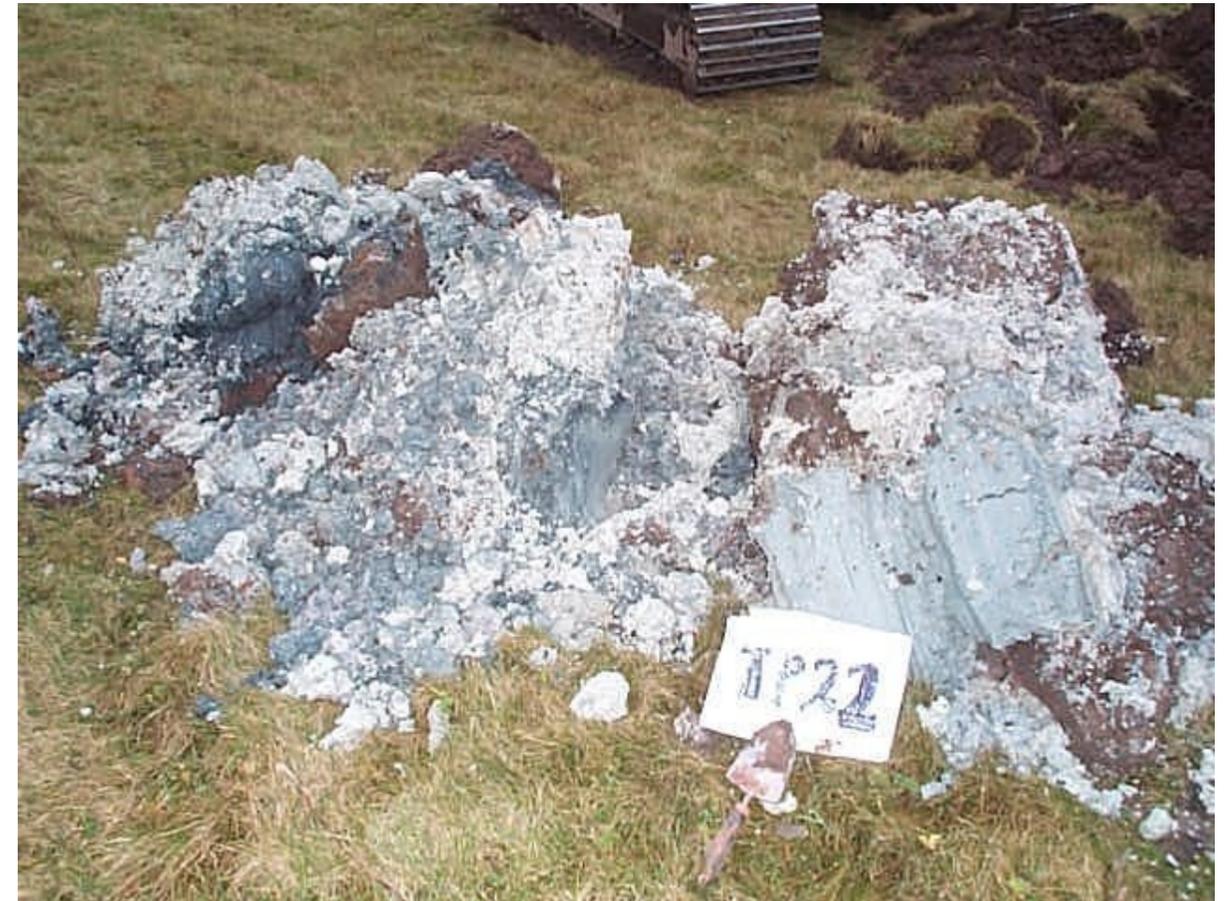
Plate 14.1(b) - Grey/white, silty, galligu chemical waste encountered in TP 22
